How Rithmik would have prevented a \$650,000 engine failure 21 days before it happened.

At a Peruvian copper mine, the OEM onboard alarm on a CAT 793F haul truck fired 7 minutes before failure. Here's what Rithmik's analytics platform saw that the onboard system missed.

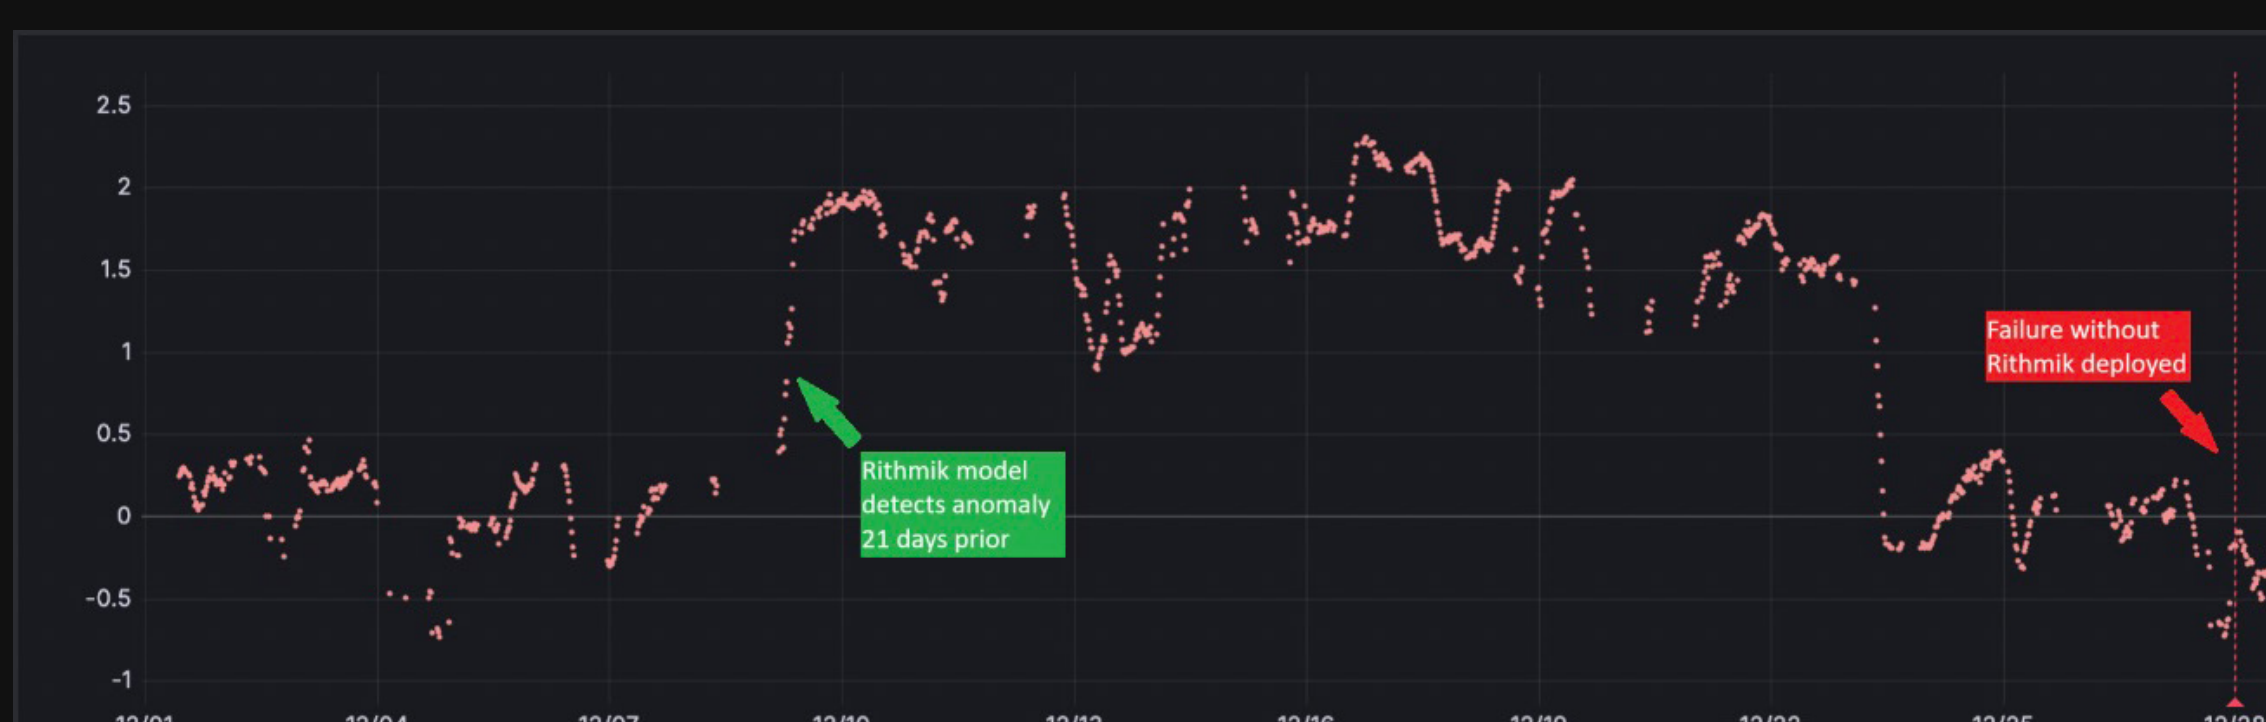
Rithmik Proprietary Analytics Model, Engine Oil Differential Pressure

Given only the truck's historical sensor data, Rithmik's analytics platform flagged an anomaly on December 7, 21 days before the failure.

A sudden step increase in engine oil restriction, subtle enough to go unnoticed by the onboard systems, was the first visible symptom of progressive damage.

On December 23, a scheduled maintenance cycle addressed the visible symptom but left the underlying damage intact. Five days later, the truck failed under maximum load. The OEM onboard alarm activated seven minutes before the failure.

<p>Failure Mode Oil contamination from maintenance event causing progressive component wear.</p>	<p>80% Confidence</p>
<p>Evidence Oil contamination likely introduced during maintenance on December 8 led to elevated filter differential pressure. Oil temperature 104°C vs coolant 93°C – suggests friction heating from metal-to-metal contact.</p>	<p>104°C Oil Temperature</p> <p>93°C Coolant Temperature</p>
<p>Category Maintenance</p> <p>Component Engine - Lubrication System</p>	<p>Date December 8</p>

On December 28, under maximum load, the compromised components failed. Oil pressure dropped, filter differential increased, oil temperature spiked, and the engine derated.
